**REMOVAL ACTION REPORT
Volume I: Final Report**

**Avery Landing Site
Avery, Idaho
TDDs: 12-05-0006/7/8/9**

U.S. Environmental Protection Agency, Region 10
1910 Northwest Boulevard, Suite 208
Coeur d'Alene, Idaho 83814

Ecology and Environment, Inc.
720 Third Avenue, Suite 1700
Seattle, Washington 98104

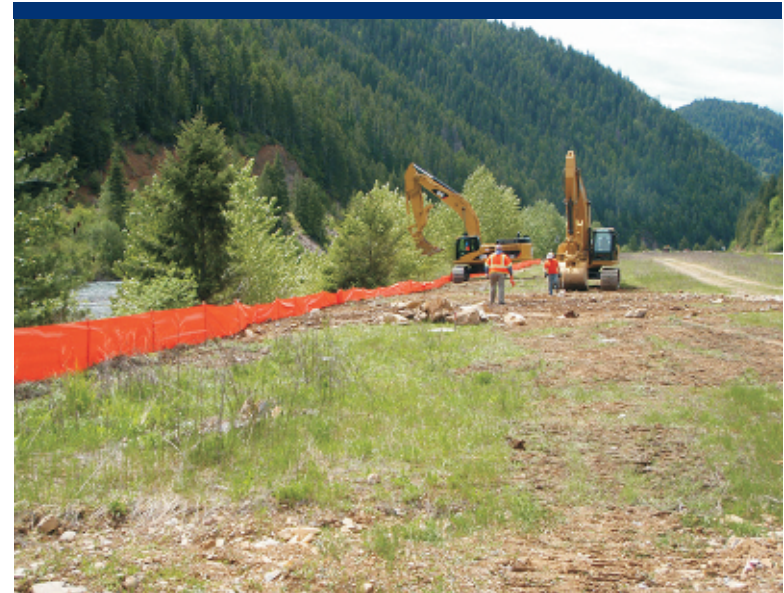
Photo 2 Preparing area for containment cell installation.

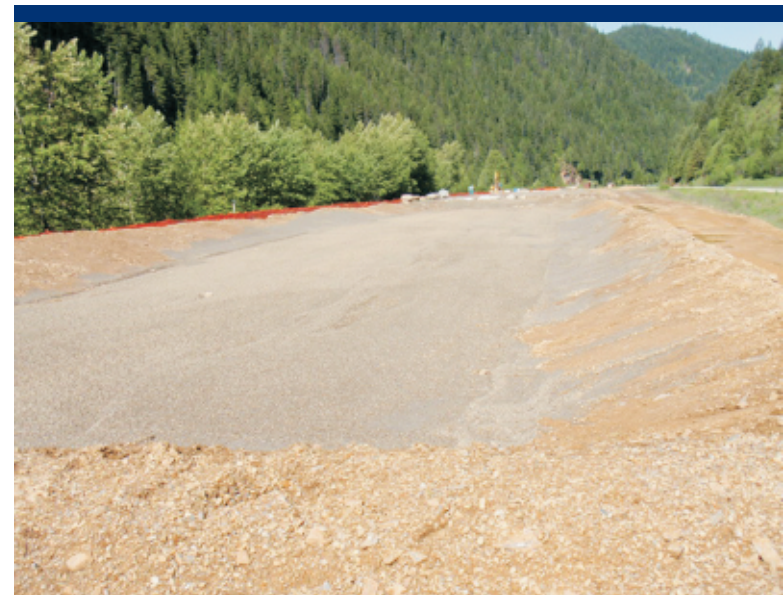
Photo 4 Gravel base for containment cell.

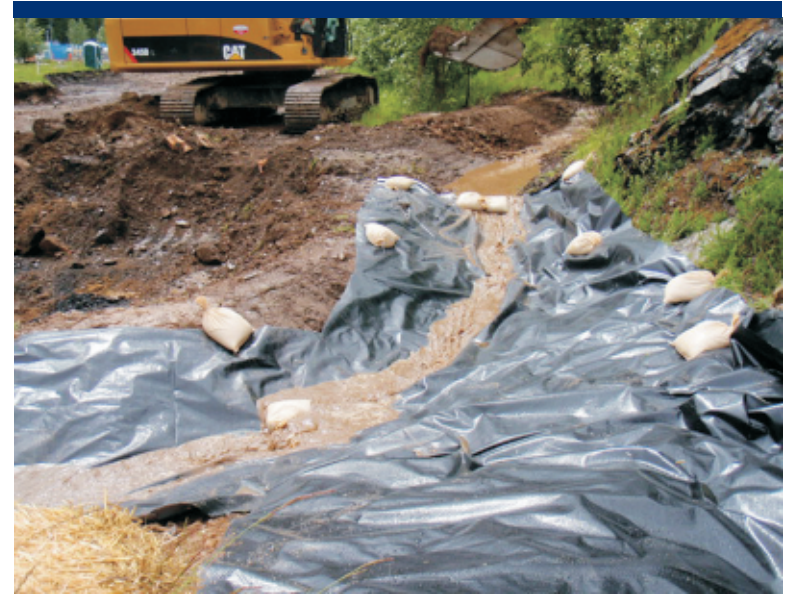
Photo 6 Beginning the diversion of the unnamed stream to bypass channel.

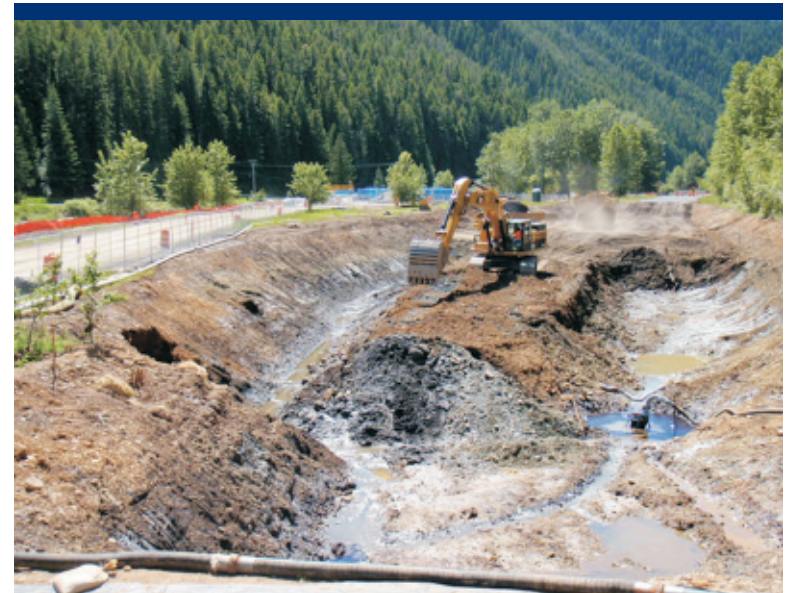
Photo 8 Federal Highway Administration (FHWA) excavation area.

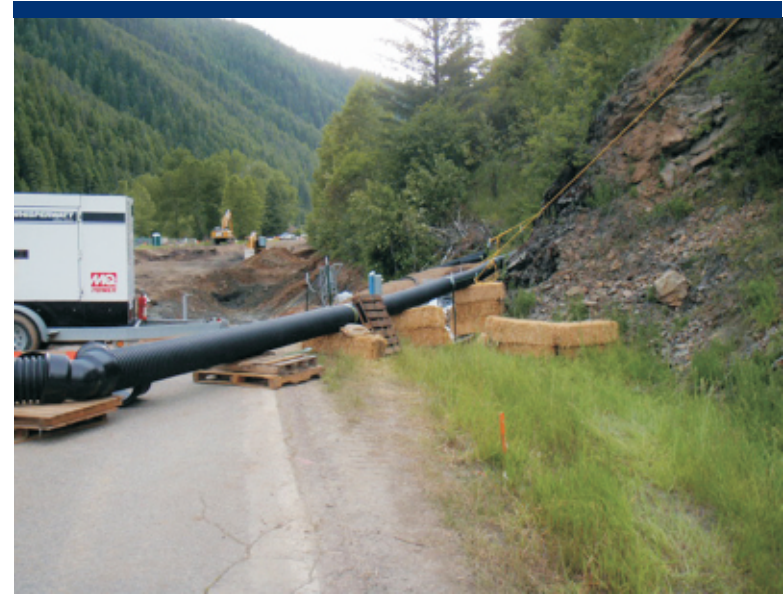
Photo 10 Piping for unnamed stream going over roadway to bypass channel.

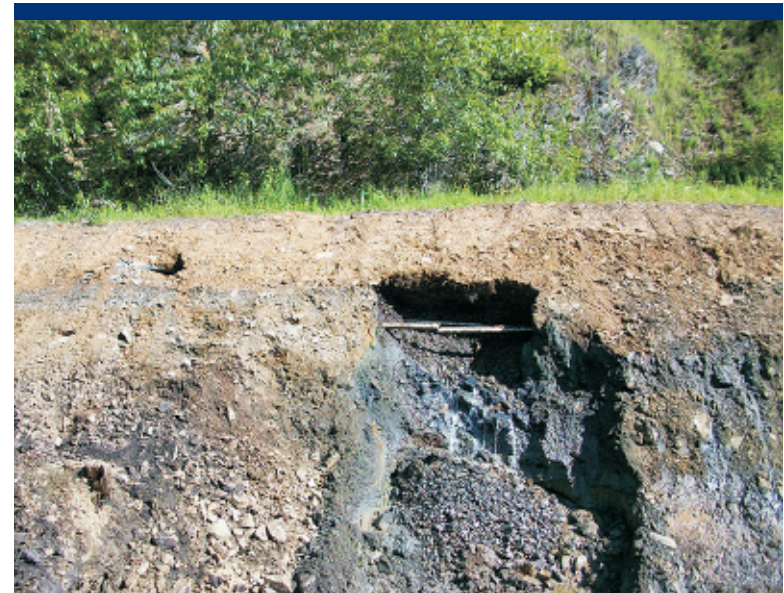
Photo 12 Infiltration trench discovered on north side of Highway 50.

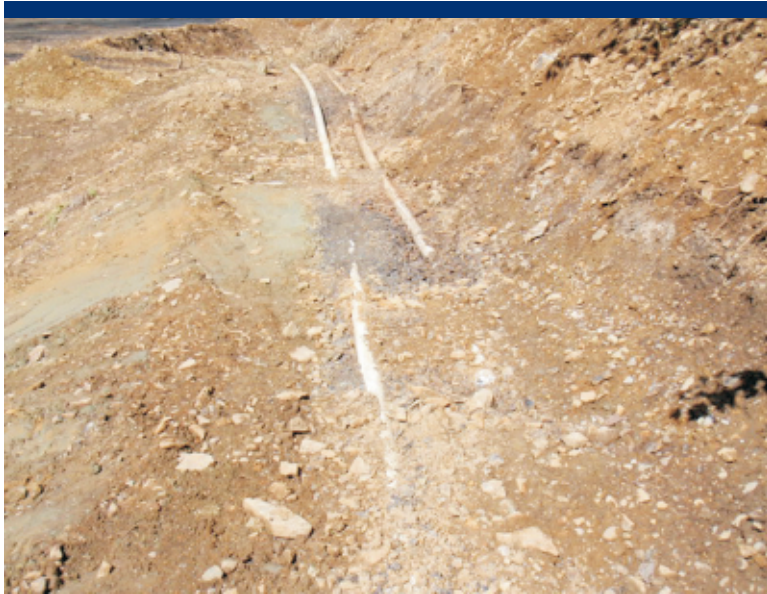
Photo 13 Infiltration trench carrier and perforated pipes on north side of FHWA excavation area.

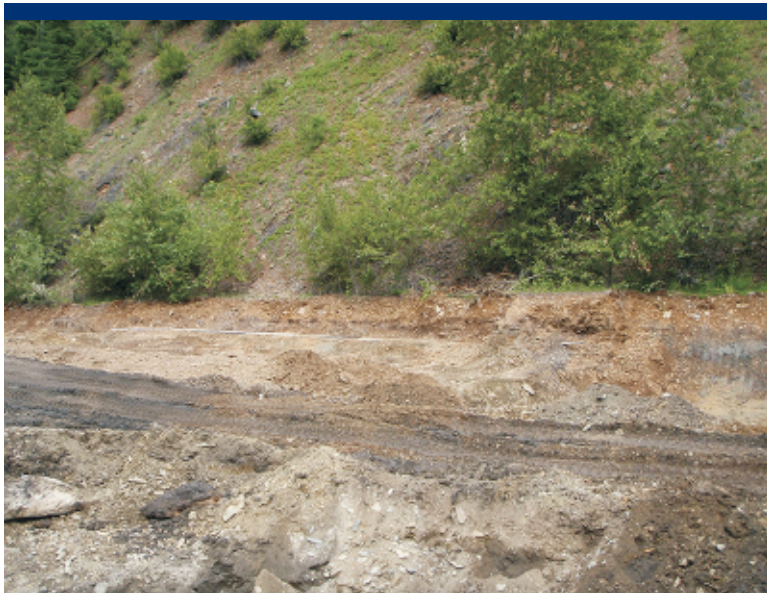
Photo 15 Infiltration trench carrier and perforated pipes with visible staining on north side of FHWA excavation area.

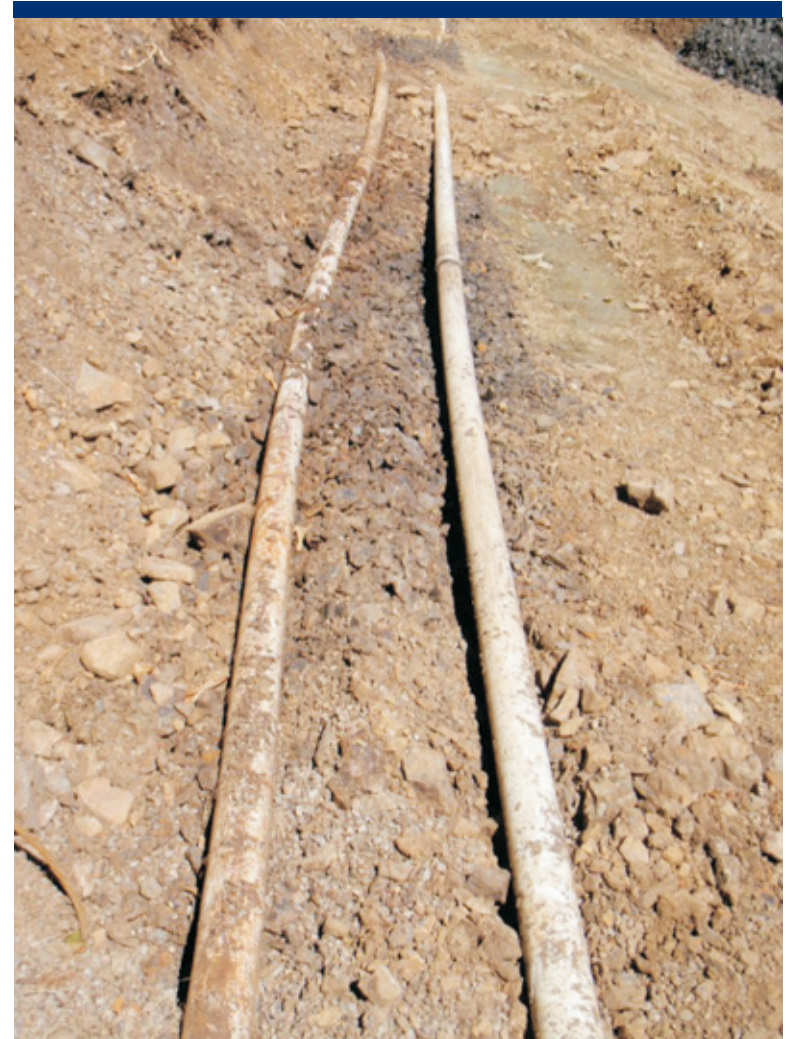
Photo 14 Infiltration trench carrier and perforated pipes on north side of FHWA excavation area.

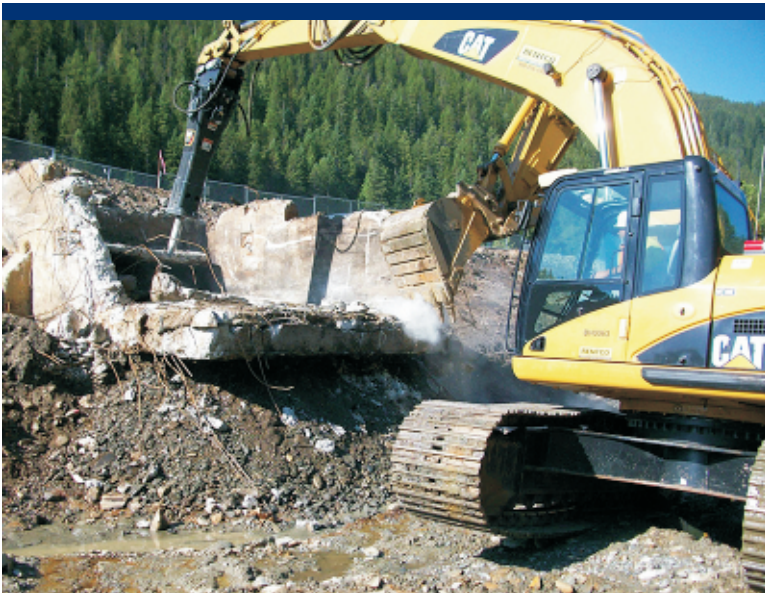
Photo 18 Large subsurface structure being broken up by hydraulic hammer.

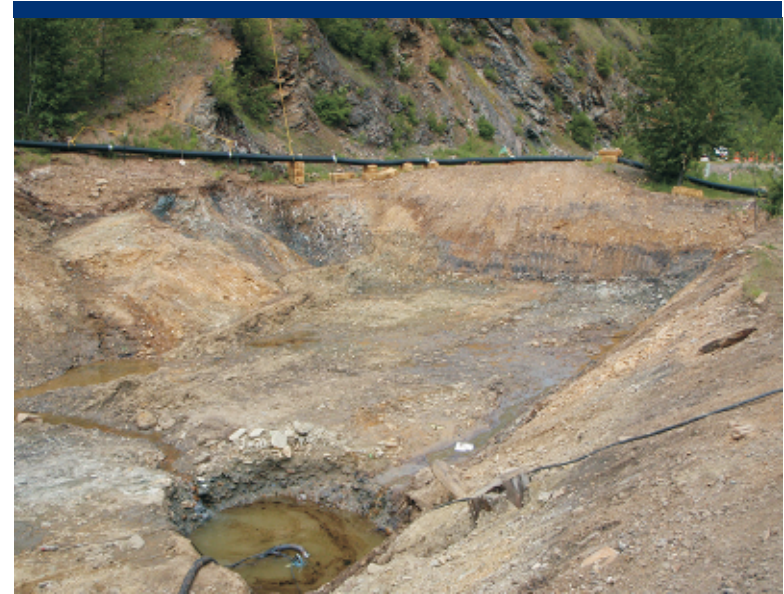
Photo 17 East end of FHWA excavation with oil/water sump pit approximately 20 feet below ground surface (bgs).

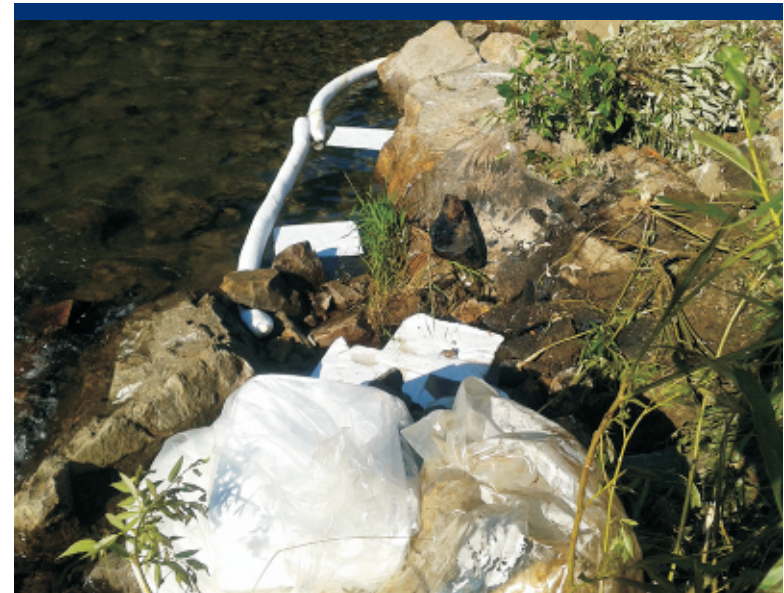
Photo 19 Oil seeping from river bank area.

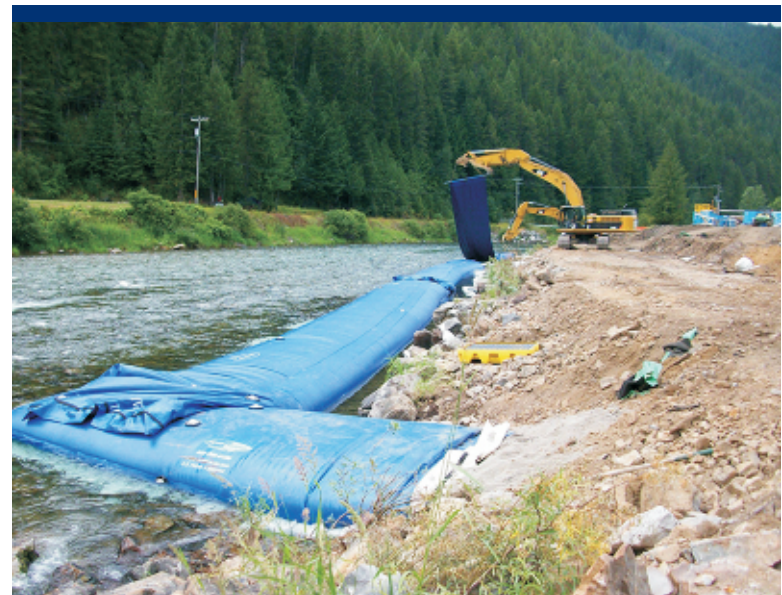
Photo 23 Cofferdam installation along river bank.

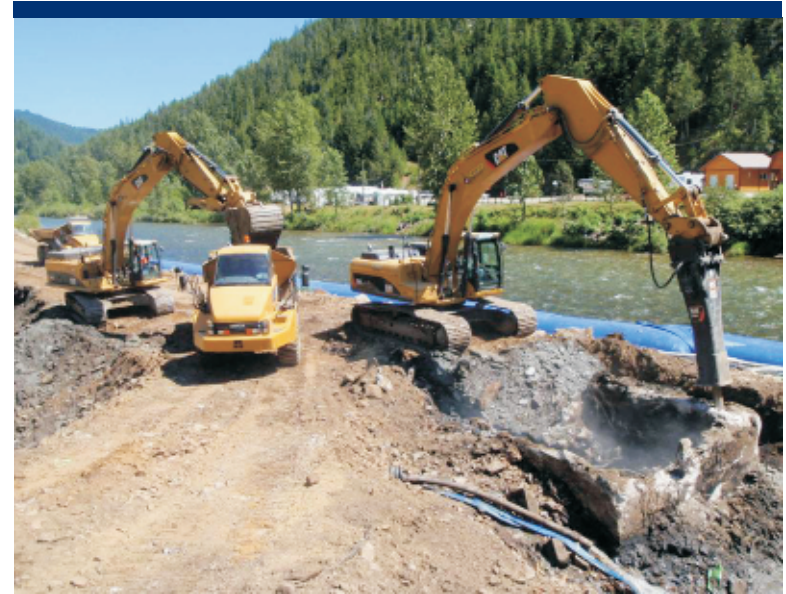
Photo 25 Concrete platform/vault being broken by a hydraulic hammer while contaminated material is excavated .

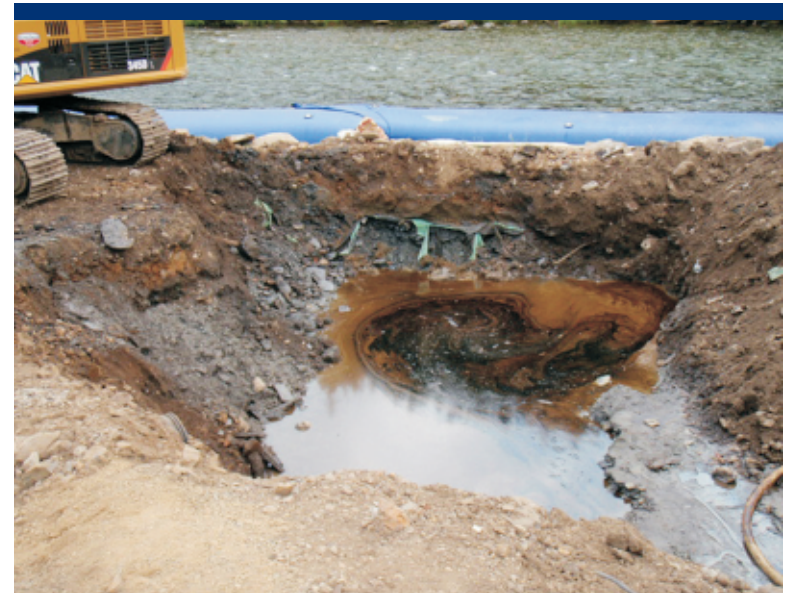
Photo 27 Residual oil in Idaho Department of Lands (IDL) excavation.

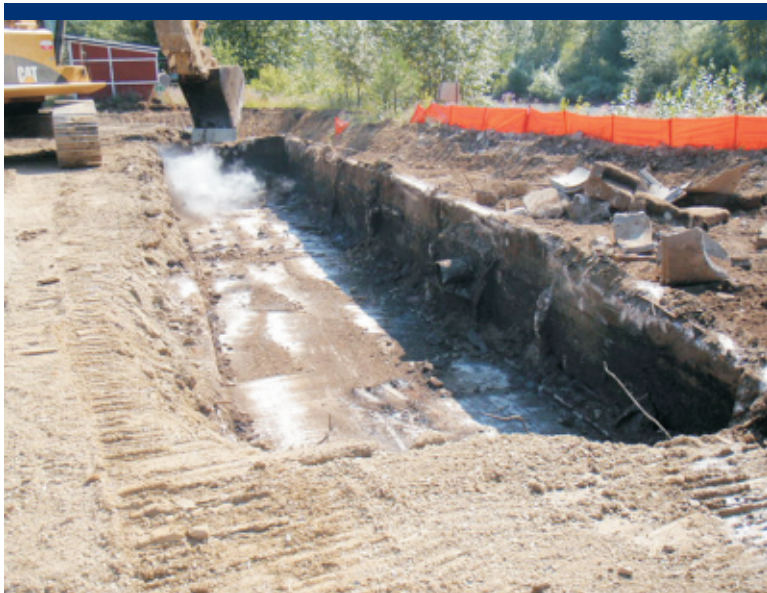
Photo 30 Building foundation on east end of Bentick after excavating soil and debris.

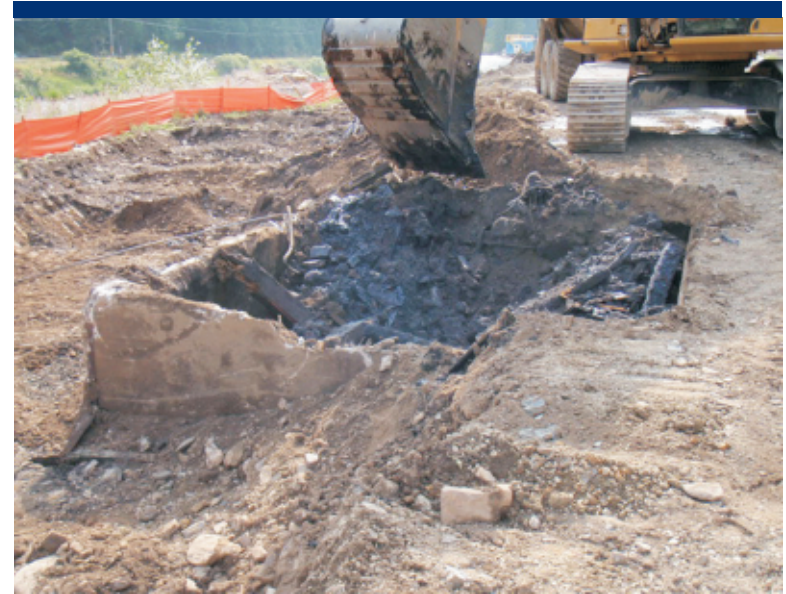
Photo 29 Excavating building foundation with bricks and bunker oil on the eastern end of Bentick property.

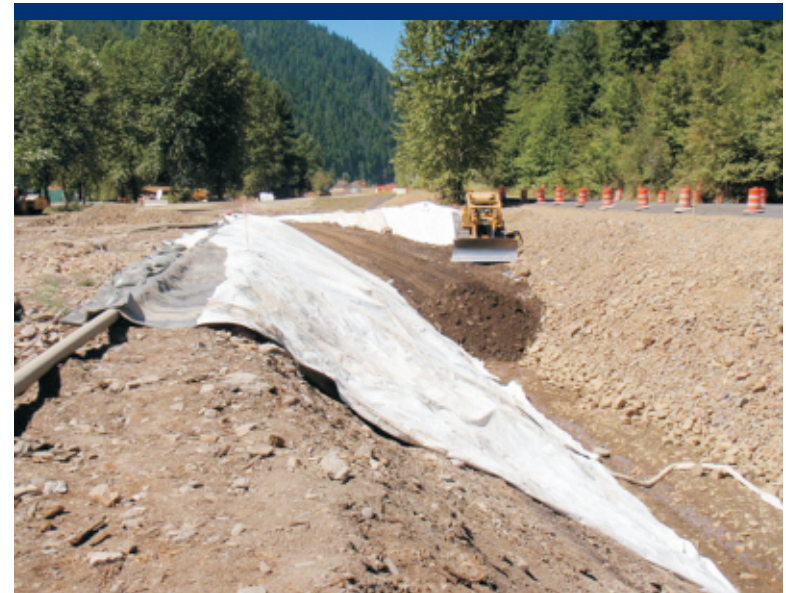
Photo 31 Installed geotextile barrier and placing clean soil in Potlatch/FHWA transition area.

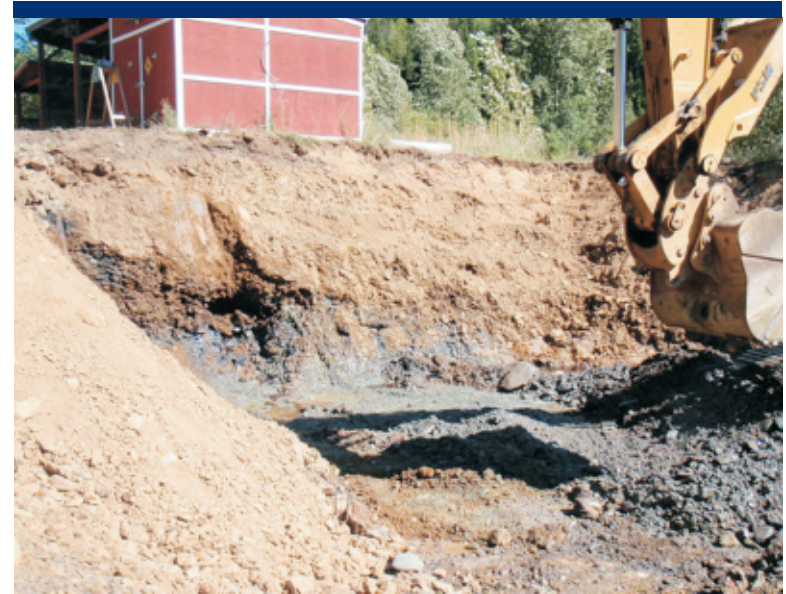
Photo 33 Excavation of oily area of eastern Bentic wall.

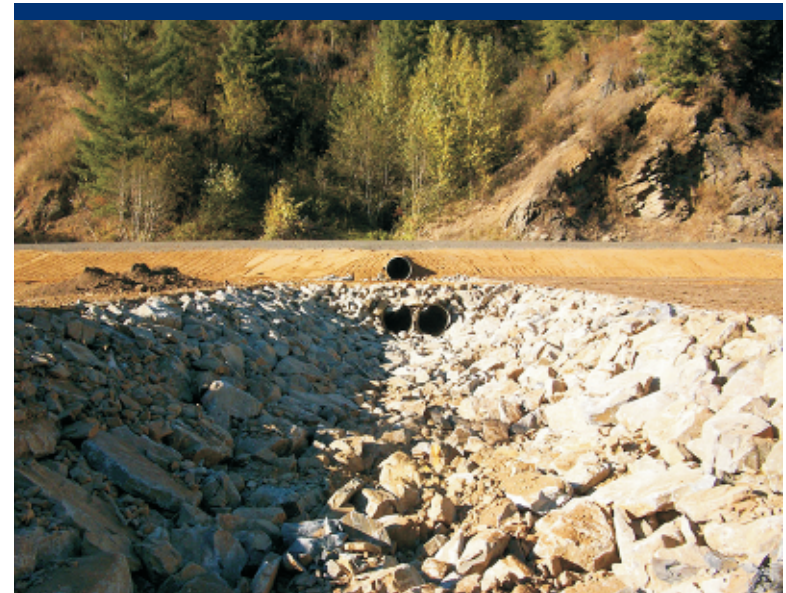
Photo 35 Culverts under highway and driveway for drainage ditch on Bentic property.

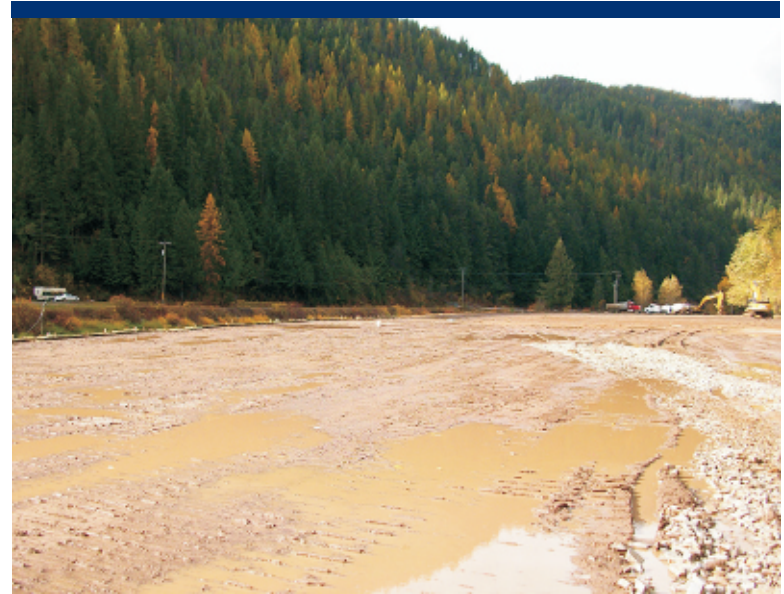
Photo 37 Benticik property restoration.

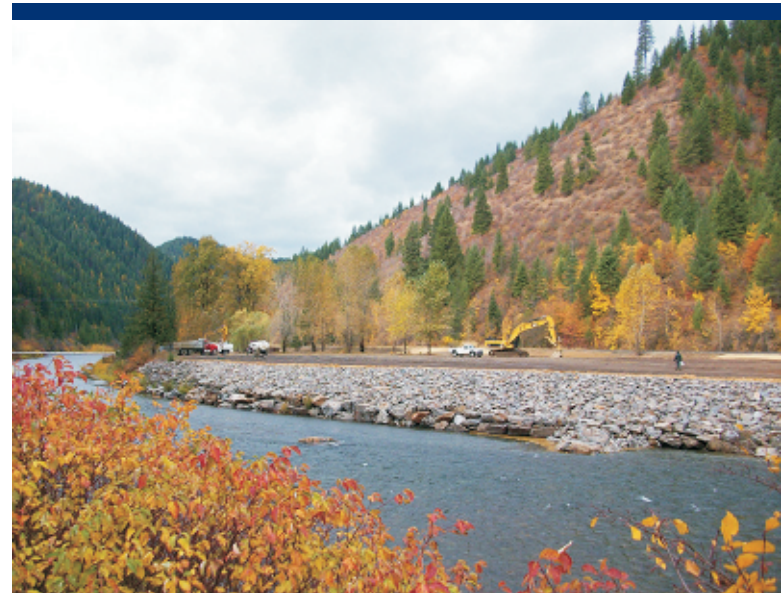
Photo 39 Avery Landing Site restoration.
